Dutch East India Company Shipbuilding

THE ARCHAEOLOGICAL STUDY OF
BATAVIA AND OTHER SEVENTEENTH-
CENTURY VOC SHIPS

Wendy van Duivenvoorde

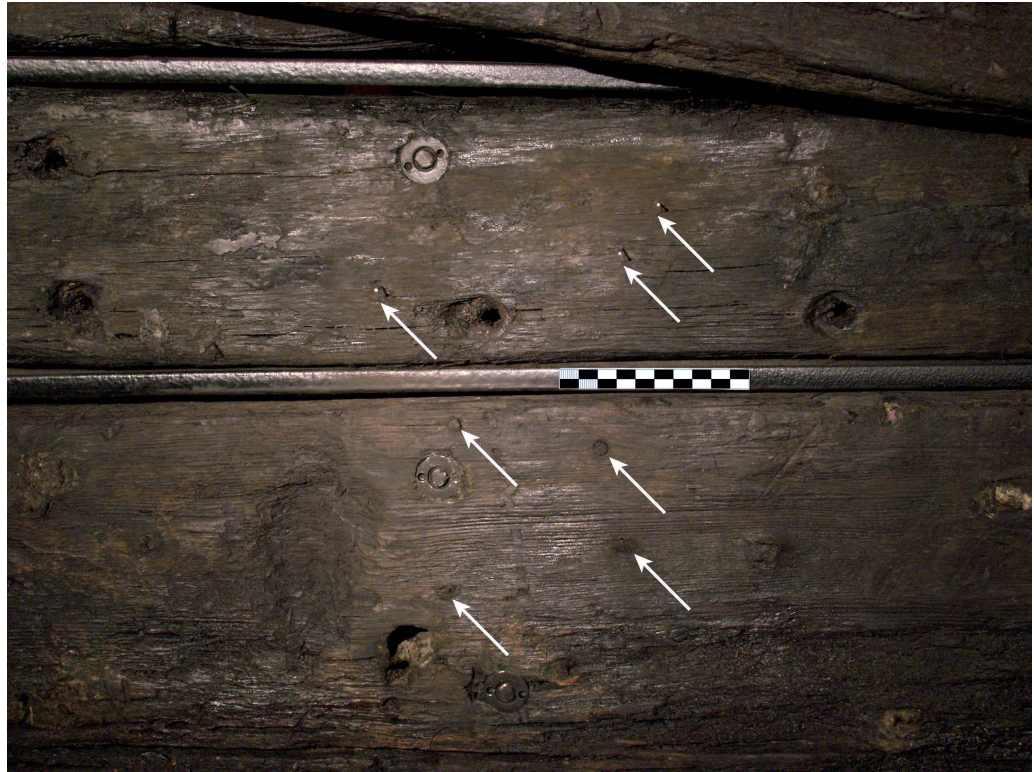
FIGURE 4-24. *Spijkerpennen* (arrows) on the exterior surface of the inner layer of hull planking directly forward of transom, BAT 6367, strake 3, and BAT 6390, strake 4. Photograph by author.

Numerous nail plugs, also known as *spijkerpennen*,³⁴ have been found on both the interior and exterior surfaces of the inner layer of oak hull planking (see fig. 4-19, 4-23, and 4-24).³⁵ Nail plugs have been observed up to strake 10, BAT 6011, of the preserved hull planking. They may occur in strakes 11 and 12 as well, but it has not been possible to record nail plugs in these strakes as they are obscured by other timbers or surface damage from sulfur-reducing bacteria. A substantial number of hull planks do not have their original surfaces preserved due to this bacterial activity. The fastening holes left behind by the temporary cleats on the planking have a cross-sectional size of 5 mm, similar to that of the filling nails used to fasten the pine sheathing to the hull planking.

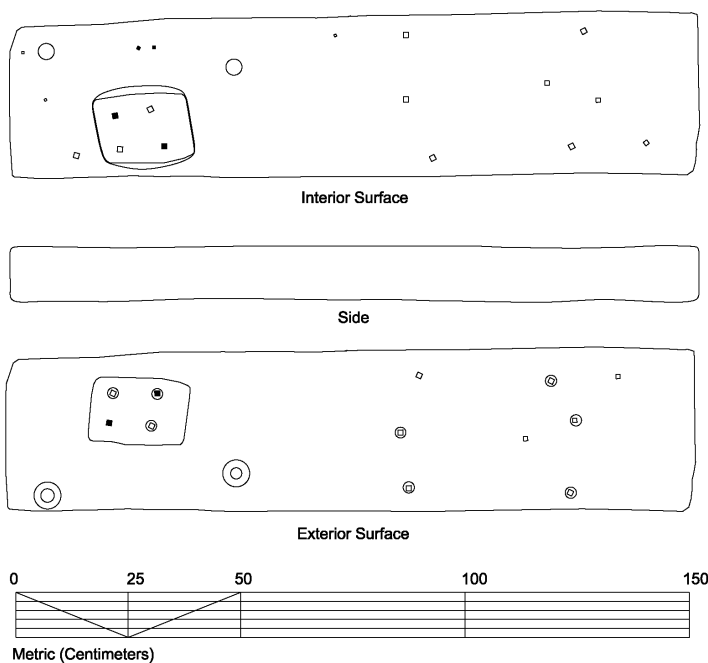
FIGURE 4-25.
Fragment of hull planking with
rectangular graving piece, BAT
6211, strake 15. Illustration by
author.

Two of *Batavia*'s graving pieces, inserted to replace knots, were roughly shaped into a quadrangle and a pentagon. The first was found in the hull planking BAT 6211 of strake 15. It measures 21.5 by 13.8 cm and goes through the entire plank thickness of 12.5 cm (figs. 4-25 and 4-26). It was nailed onto the underlying timber with four square-shanked nails measuring a maximum of 1.5 cm in cross section.

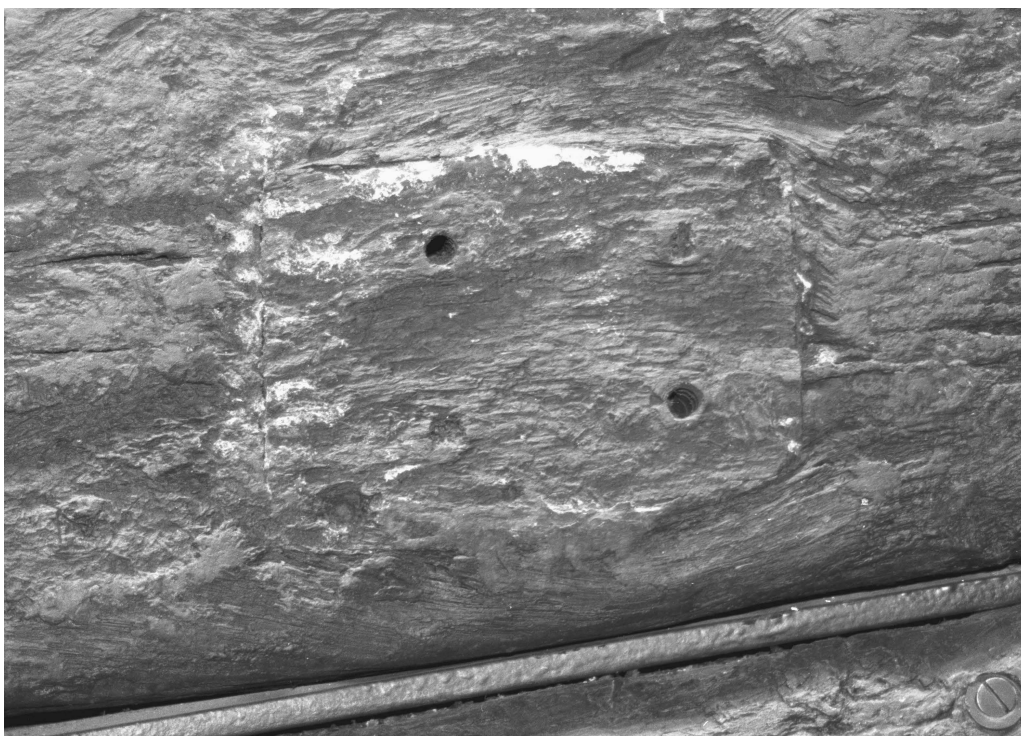
FIGURE 4-26.
Rectangular graving
piece, BAT 6211, strake
15. Photograph by
Patrick Baker, Western
Australian Museum
(MA4864-27).

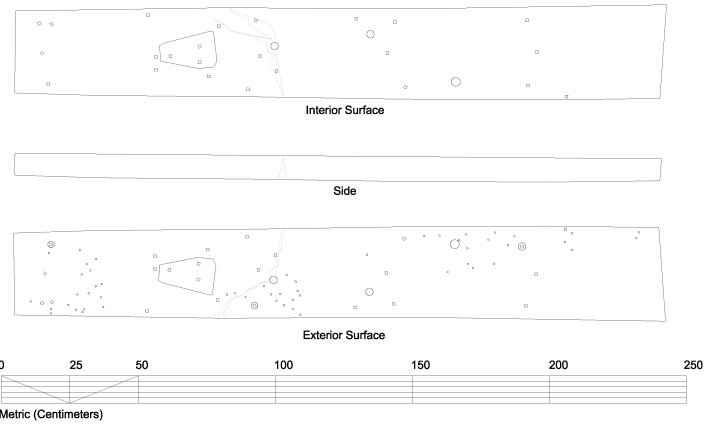
FIGURE 4-27.

Fragment of hull planking with pentagonal graving piece, BAT 6109, strake 12. Illustration by author.

The graving piece in the shape of a pentagon is preserved on the outer layer of hull planking BAT 6109 in strake 12. It measures 20.3 cm over its top length and tapers over its width from 13.2 to 5.6 cm. The foremost corners are chamfered, and the lower edge is divided into two faces, measuring 13.9 and 5.9 cm in length (fig. 4-27).

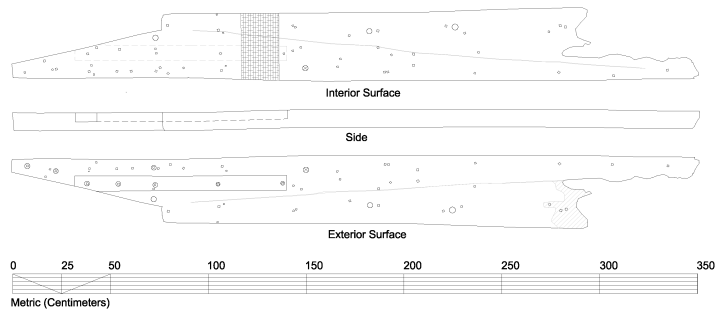
FIGURE 4-28.

Fragment of hull planking with rectangular graving piece, BAT 6206 and BAT 6074, strake 11. Illustration by author.

The third graving piece, not visible today, is preserved at the scarf tip on the exterior surface of the inner layer of hull planking BAT 6206 and BAT 6074 of strake 11, seven strakes below the gun port (figs. 4-28 and 4-29). The rectangular wooden insert was probably used to replace a crack or growth irregularity in the scarf tip, because it is too long

and narrow to have been used to replace a knot. It measures 1.08 m in length and 7.7 cm in width. It does not replace the entire thickness of the inner layer of hull planking, as it is evident only on the exterior.³⁷ It was nailed to the inner layer of hull planking with five square-shanked nails.

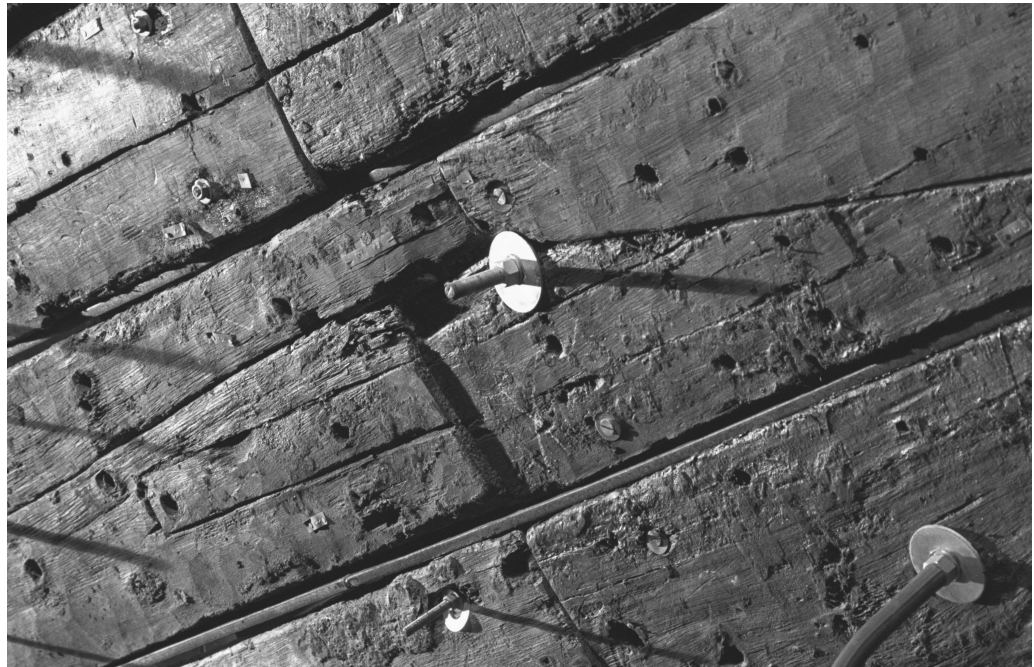
FIGURE 4-29.

Rectangular graving piece forward of scarf end on exterior of inner layer of hull planking, sawn into two sections during excavation, BAT 6206 and BAT 6074, strake 11. Photograph by Patrick Baker, Western Australian Museum (MA4068-10).

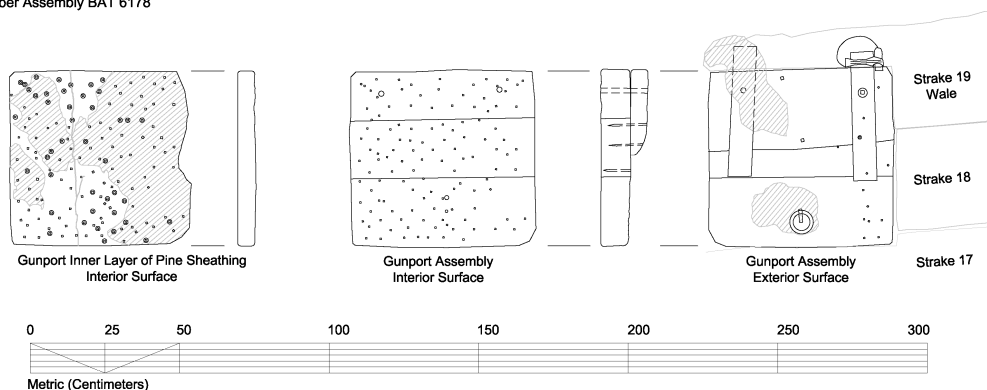
Batavia Shipwreck
Reconstruction of Gunport Lid
Timber Assembly BAT 6178

FIGURE 4-30. Gun port lid assembly from hull planking strakes 17–19, BAT 6178. Illustration by author.

The lid of the gun port on the side of the ship is still present and consists of a complex assembly of three layers of wood. It measures 58.6 cm in height and 61.5 cm in width and fits tightly into the port. The innermost layer of the lid consists of a pine sheathing board that covers the entire area of the lid (fig. 4-30). It measures 5.7 cm in thickness. The board was fastened to the lid's second layer with closely spaced iron nails, with rounded heads and square shanks, in a quincunx pattern. It was applied in exactly the same method as the layer of pine sheathing to the exterior of the hull planking. The circular impressions of the iron nail heads have an average diameter of 1.5 cm, and the nail shanks measure 6 mm square in section directly below the nail head and taper to a point.

the reconstruction shown in figure 4-30 could be made. The hinges followed the profile of the exterior surface of the lid and were bent to accommodate the transition between the extra plank on top and the lower half of the lid. A large spike or bolt at the top of each hinge ran through the two layers of oak below. In addition, the hinges were nailed to the lid's exterior surface with several iron nails.

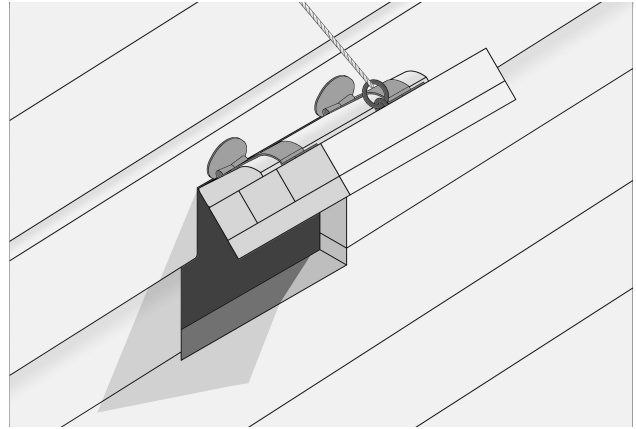
FIGURE 4-31.

Isometric drawing of gun port lid assembly, BAT 6178. Illustration by Mark Polzer and author.

The second layer of the lid, which sits flush within the strakes of the hull planking, consists of three thick oak planks fitted horizontally (fig. 4-31). They measure 9.9 cm in thickness and were held together by the sheathing board on the interior. As the gun port is located at the bottom of *Batavia*'s third wale, one additional horizontal plank was fastened to the top exterior surface of the lid to create a continuation of the ship's wale. This top plank, although eroded, measures 6 cm in thickness and 24.3 cm in width. It was fastened to the gun port lid with two large spikes or bolts that ran from the lid's hinges on the exterior to its interior face.

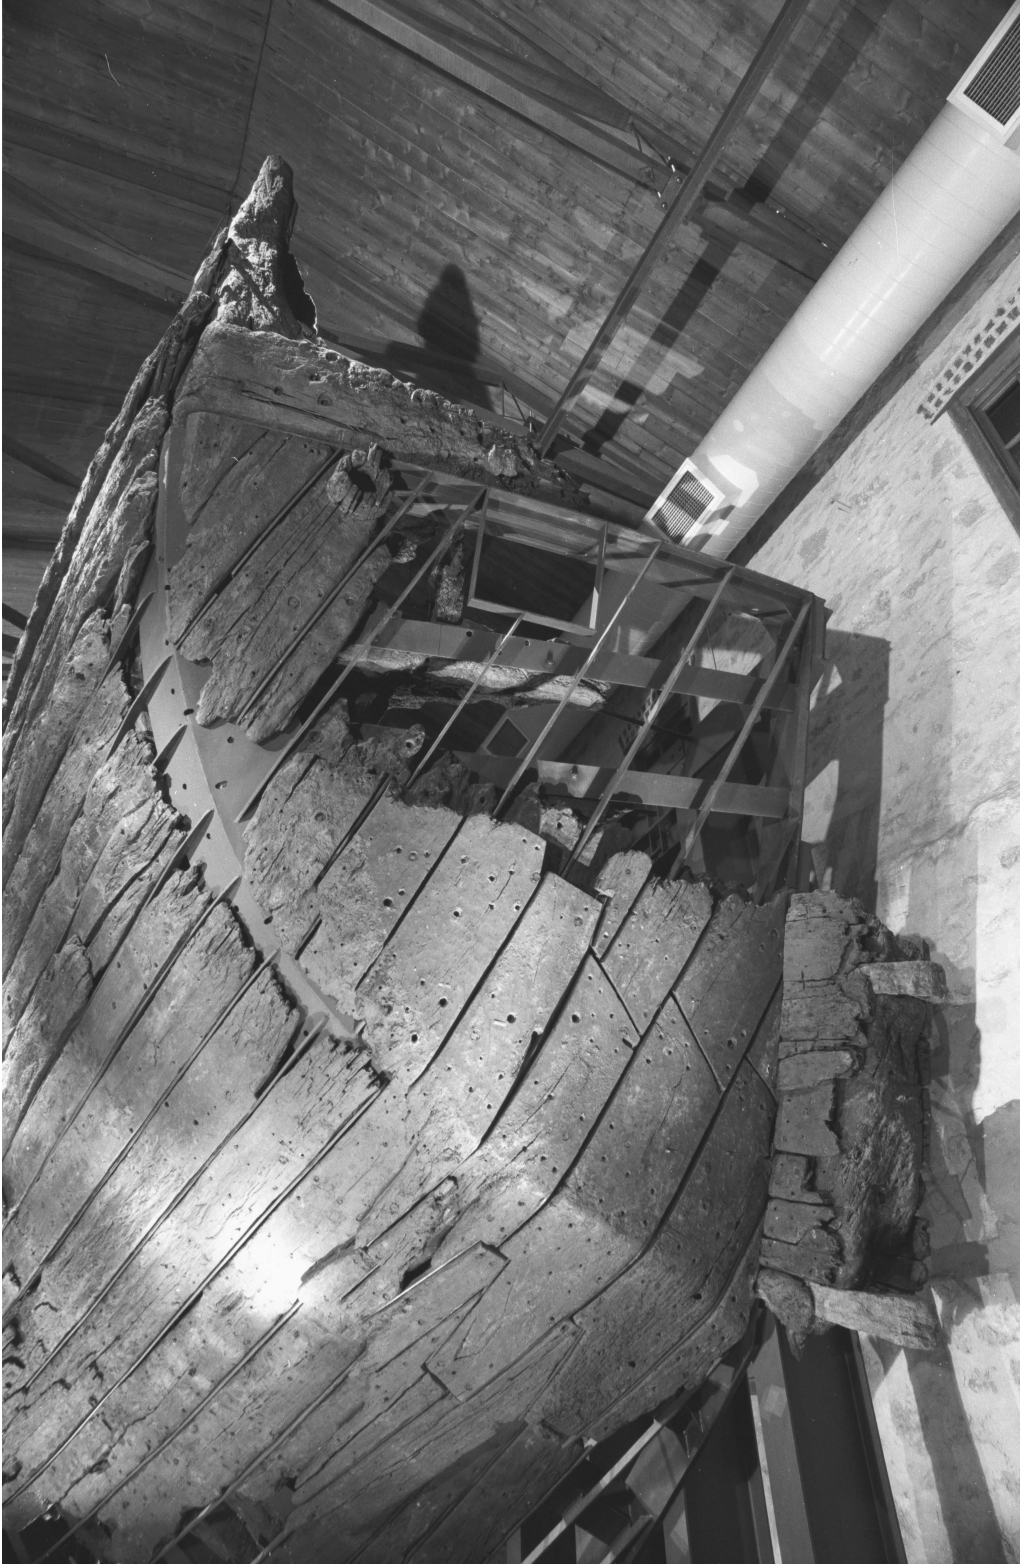
FIGURE 4-32. Port-side transom planking and sternpost. Photograph by Patrick Baker, Western Australian Museum (MA5048-30).

The transom planks of *Batavia*'s hull curve in both transverse and longitudinal planes (fig. 4-32). They are not distorted but were cut to create this convex shape, as was the wing transom, which follows this transverse curvature. Furthermore, the scant remains of the sternpost's rabbet line show this longitudinal curvature on the ship's starboard side. The transom was planked, like the ship's bottom, with two layers of oak hull planking (figs. 4-33 through 4-35). These two layers are more or less equal in thickness, like the double layers of hull planking. The thickness of the inner layer of transom planking varies between 9.0 and 10.4 cm, averaging 9.5 cm. The outer layer is slightly thinner; the thickness varies from 8 to 9.4 cm, averaging 8.9 cm. Van IJk mentions that transom planking was allowed to be one-third thinner than hull planking.³⁹ The *Batavia* transom planking, however, does not confirm this practice. The transom planking is joined with diagonal scarfs, and both layers were fastened in place with iron spikes.

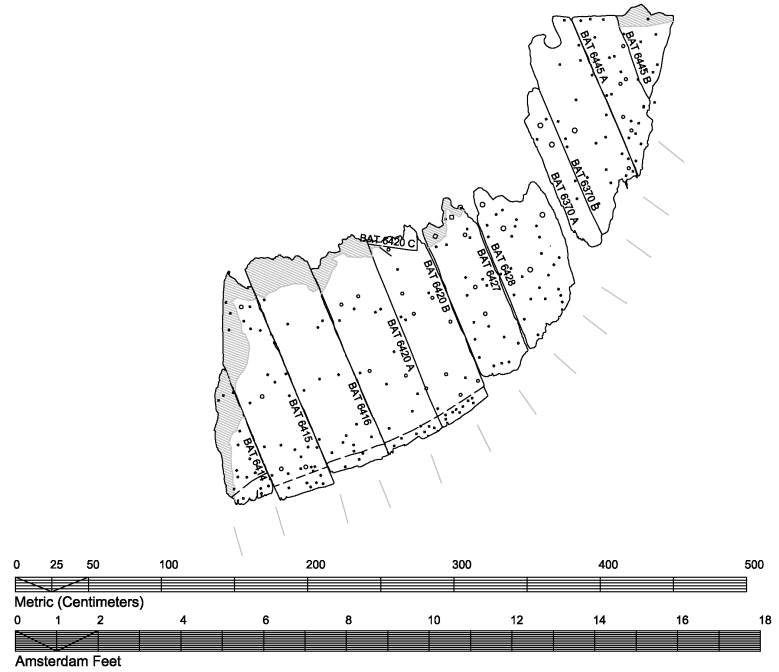
FIGURE 4-34.
Outer layer of transom
planking, interior face,
port side, corresponding
to preserved outer
hull strakes 3–12. The
inner layer of transom
planking is outlined in
gray in the background
for orientation.
Illustration by author.

On the interior surface of the outer layer of transom planking a shallow, rectangular mortise was cut to receive the starboard end of the gudgeon (see figs. 4-34 and 4-37). This mortise measures 63.2 cm (2 Amsterdam ft, 2.5 thumbs) in length, 16.7 cm (6.5 Amsterdam thumbs) in width, and 3.8 cm (1.5 Amsterdam thumbs) in depth and flares out, about 10 cm from its end, to 20.1 cm in width. A thick layer of goat hair and a resinous substance were found in the mortise that provided extra waterproofing. The ends of the gudgeons thus extended outward from the sternpost to beneath the outer layer of transom planking, where they were nailed in place with two iron spikes per side. The impressions of the spike heads are clearly visible in the outer layer of transom planking and measure 3.2 cm (1.25 Amsterdam thumbs) in diameter. This demonstrates that the outer layer of transom planking was applied after the sternpost's gudgeons were installed, most likely in the final stage of construction. The outer layer of transom planking around the gudgeon ends was therefore added much later in the construction process than the outer layer of hull planking, which was installed after the frames were inserted. Transom planks BAT 6413 B, BAT 6417 B, and BAT 6421 were probably pre-assembled before they were placed over the gudgeon ends and fastened to the inner layer of transom planking, as three transverse nails were found along the edges of plank BAT 6417 B (see fig. 4-34).

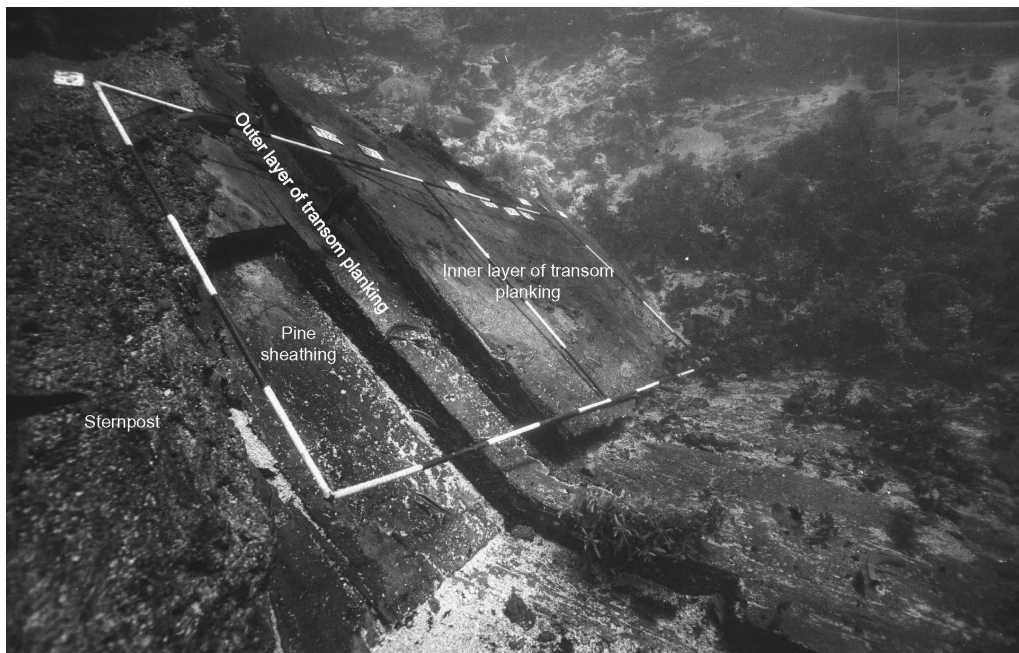
FIGURE 4-35. Inner and outer layer of transom planking on the seabed. Photograph by Jeremy Green, Western Australian Museum (MAO412-22).

angle of 152 degrees between two plank ends on its interior surface, whereas the highest, BAT 6423, has an angle of 140 degrees (figs. 4-35 and 4-36). All tool marks from adzes and saws found on these five transom planks indicate that they were carved to create a corner plank (fig. 4-36). The diagonal direction and spread of the adze marks, particularly on the interior surfaces around the plank's bend, clearly indicate that the roughly sawn timber was adzed into shape. Saw marks run in diagonally opposing directions toward the bends in the planks. These tool marks do not provide any evidence to suggest that the sharp angles were a result of bending the planks to create an extreme angle in their centers.

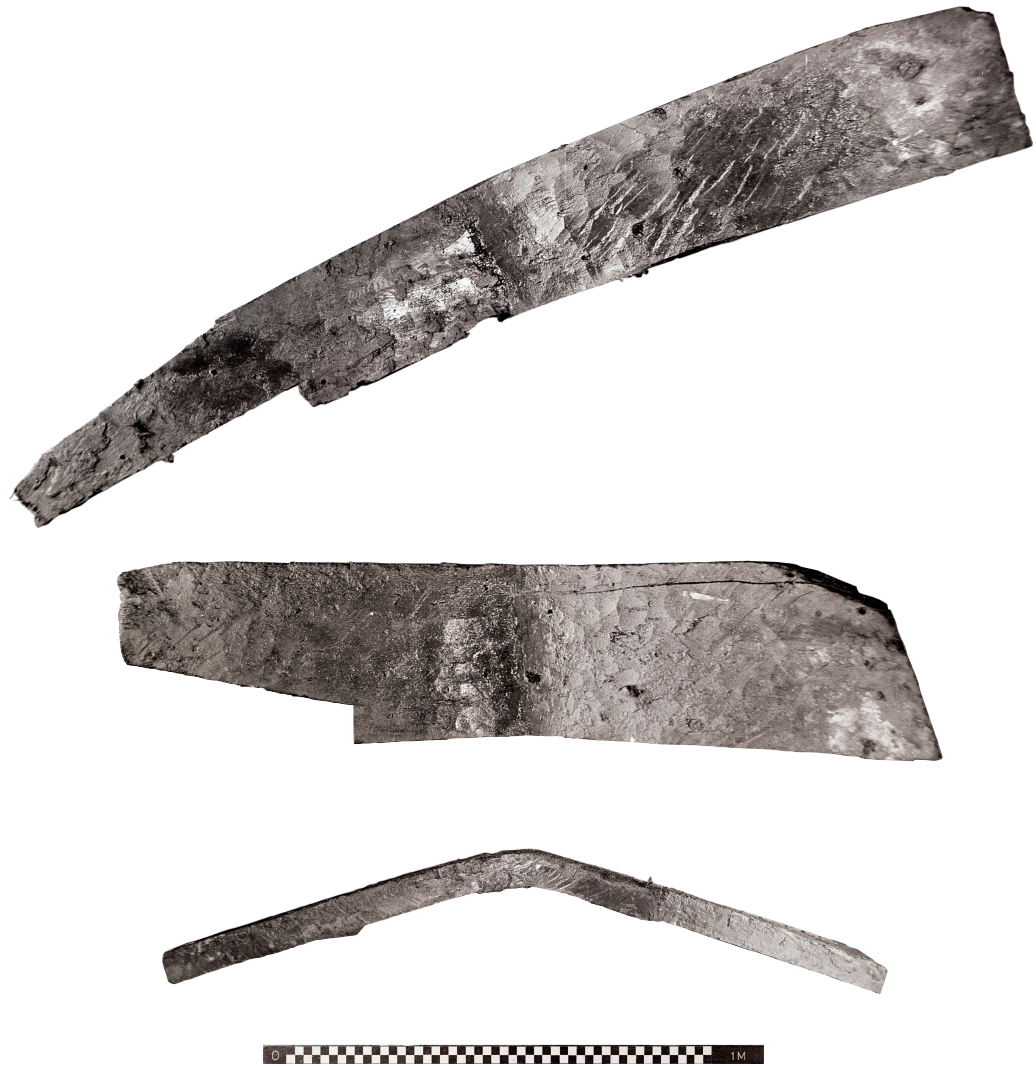
FIGURE 4-36.

Axe and adze marks on the interior surface of transom plank BAT 6423 (*top*); adze marks on the interior surface of transom plank BAT 6413 (*center*); and saw marks on the edge of the transom plank BAT 6417 (*bottom*). Photographs by Patrick Baker, Western Australian Museum (MAO422-26, MAO422-21, and MAO422-32).

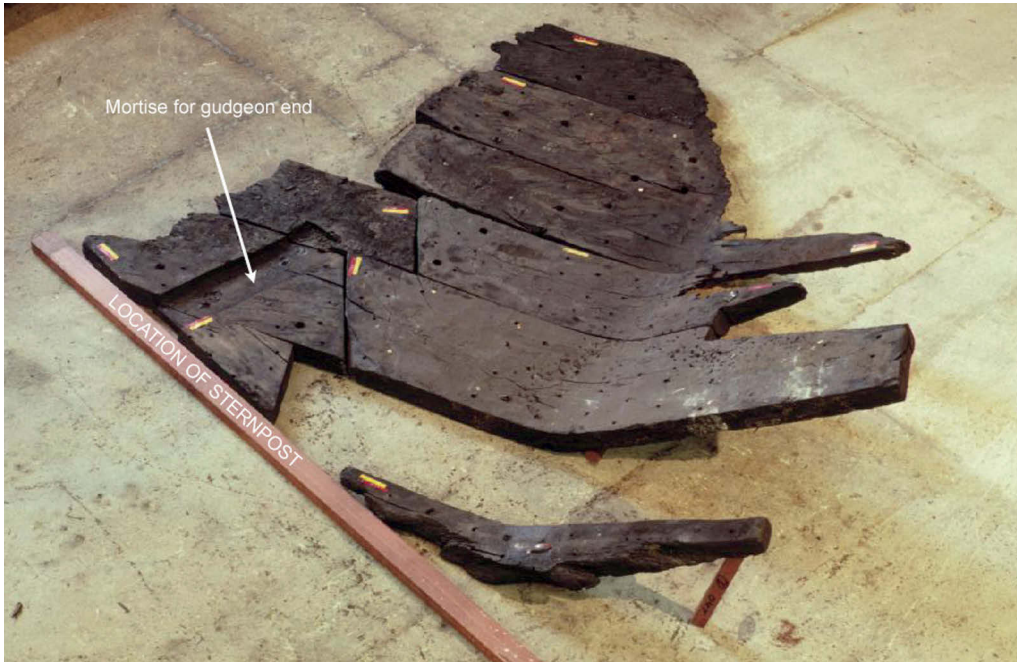
FIGURE 4-37.
Interior surface of
outer layer of transom
planking laid out on
the museum's gallery
floor during reassembly.
Photograph by Brian
Richards, Western
Australian Museum
(BT-T-0199).

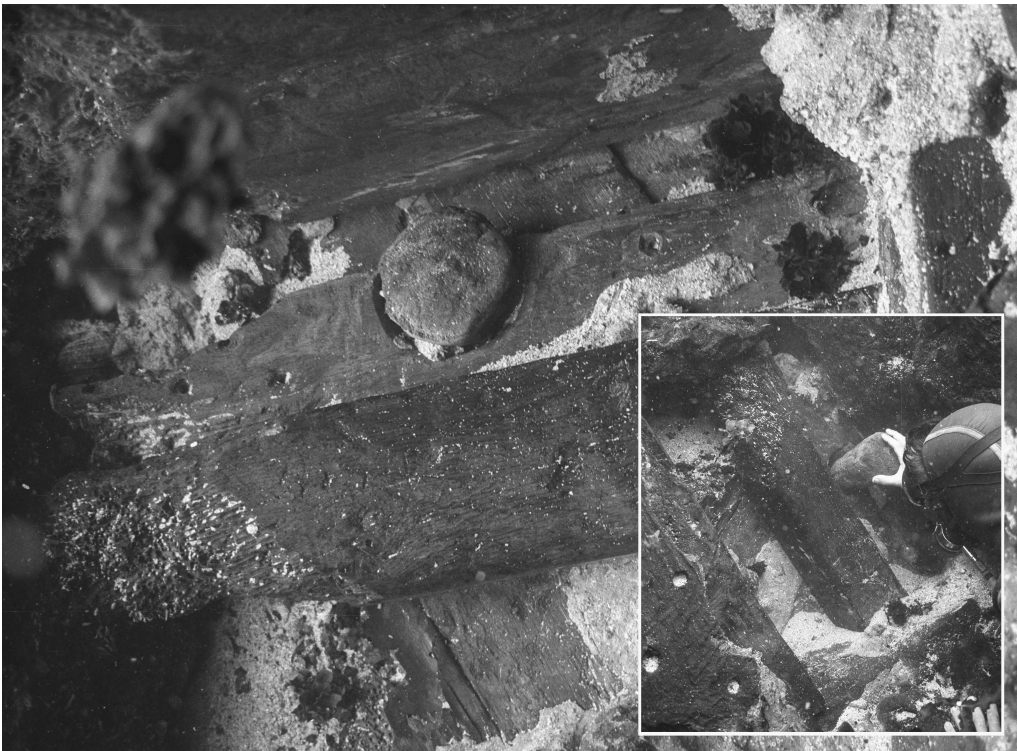
FIGURE 4-38.
Bung from cathole
in the transom, port
side, interior face, BAT
6235. Photographs by
Patrick Baker, Western
Australian Museum
(MA0289-17 and
MA0289-23).

Since *Batavia* was under full sail and was not towing a boat at the time of its sinking, the hawse hole was plugged with a bung on its interior (fig. 4-38). This bung was still in place during the ship's excavation. It measures 24.8 cm in length, is round in section, and tapers from 13 to 8.1 cm in diameter.

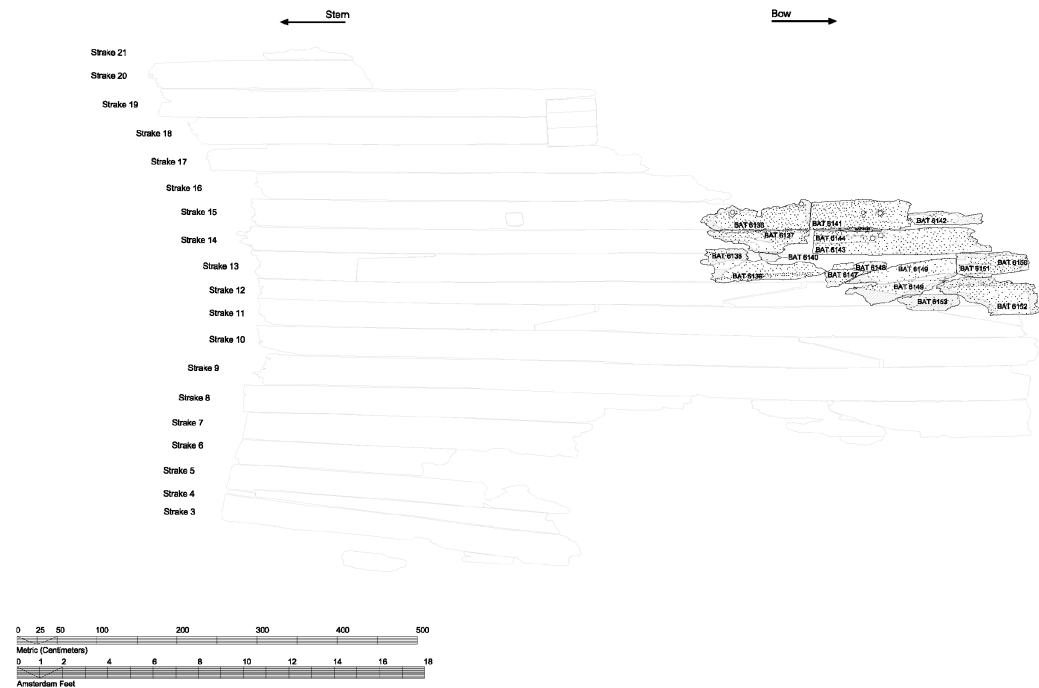
FIGURE 4-39.

Timber plan of inner layer of pine sheathing, preserved strakes 12–15, port side, interior surface. The inner layer of hull planking is outlined in gray in the background for orientation. Illustration by author.

Batavia's hull was sheathed with pine planking, up to at least its fifteenth preserved strake (figs. 4-39 and 4-40). The pine sheathing has a maximum thickness of 4 cm. Some fragments of the sheathing that were poorly preserved on the seabed have been preserved at the forward ends of strakes 12–15. These fragments, some originally belong-

On the exterior surface of strake 14, two layers of pine sheathing were applied, most likely to compensate for the loss of 5.5 cm of hull thickness between strakes 13 and 14. It adjusts discontinuity in the ship's exterior surface. The inner layer of pine was 4 cm thick, whereas the outer layer tapered in thickness from the center to its seams (see figs. 4-39 and 4-40).

The pine sheathing remnants at strakes 14 and 15 show that round holes were cut in the planks, varying from 5.1 to 6.4 cm in diameter, to fit the sacrificial planking neatly around the heads of large iron bolts that probably fastened the ship's riders to the ceiling planking, frames, and hull planking (see figs. 4-39, 4-40, and 4-42). Iron filling nails were spaced neatly around the holes that seat the bolt heads.

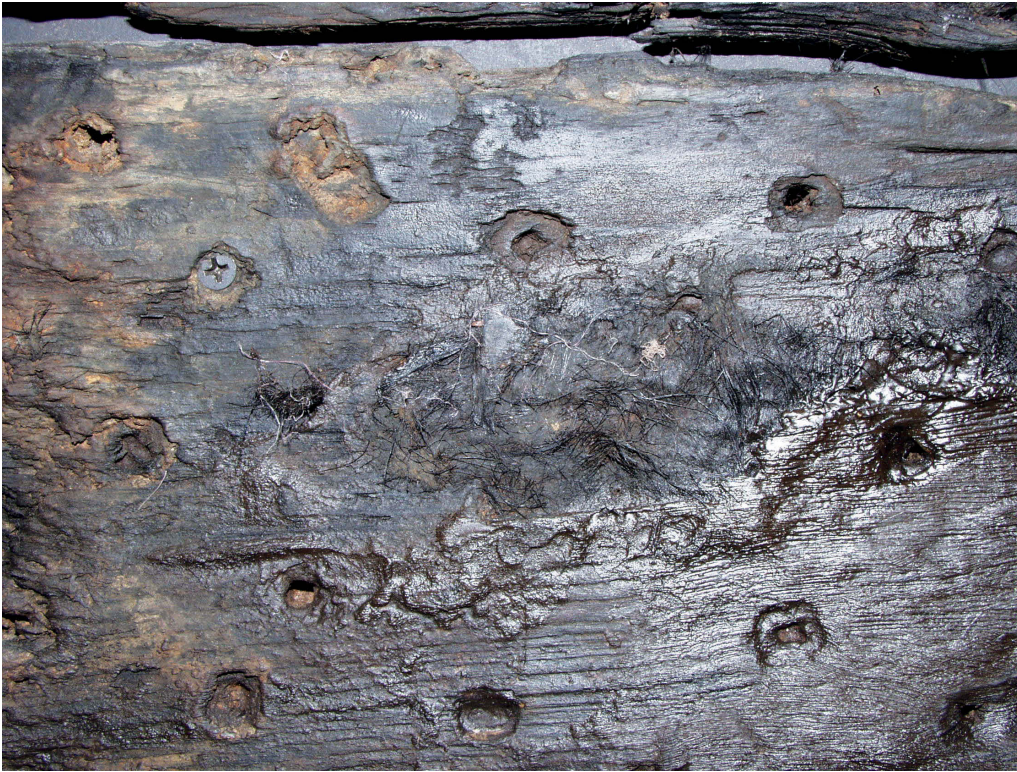
FIGURE 4-41. Nail holes with nail head impressions and some goat hair on the exterior surface of pine sheathing, BAT 6241. Photograph by author.

Thin layers of animal hair, approximately 5 mm in thickness, were applied to the outboard surfaces of the two layers of *Batavia's* hull planking (fig. 4-44). Some hair was also found on the outboard surface of the pine sheathing on the sternpost (see fig. 4-41). This layer will simply be referred to as hair to be consistent with the terminology used in nautical documents dating to the seventeenth century.⁴³ The layer of animal hair between the planking and sheathing was mainly intended to be a bulking agent for the tar, to deter wood rot, and to keep teredo worms from boring into the bottom planking.

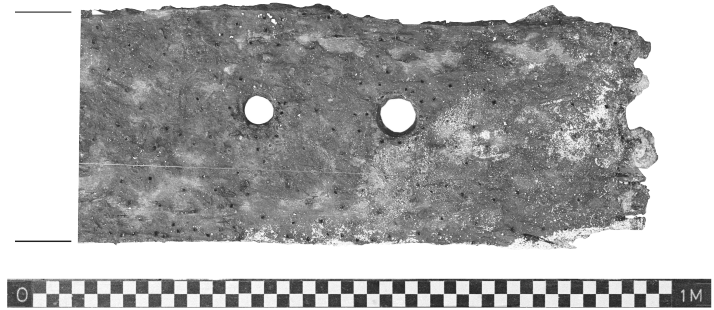
FIGURE 4-42.
Interior surface of pine
sheathing plank BAT 6141,
strake 15. Note sheathing
nails spaced neatly around
bolt head holes. Photograph
by Patrick Baker, Western
Australian Museum
(MA0199-27).

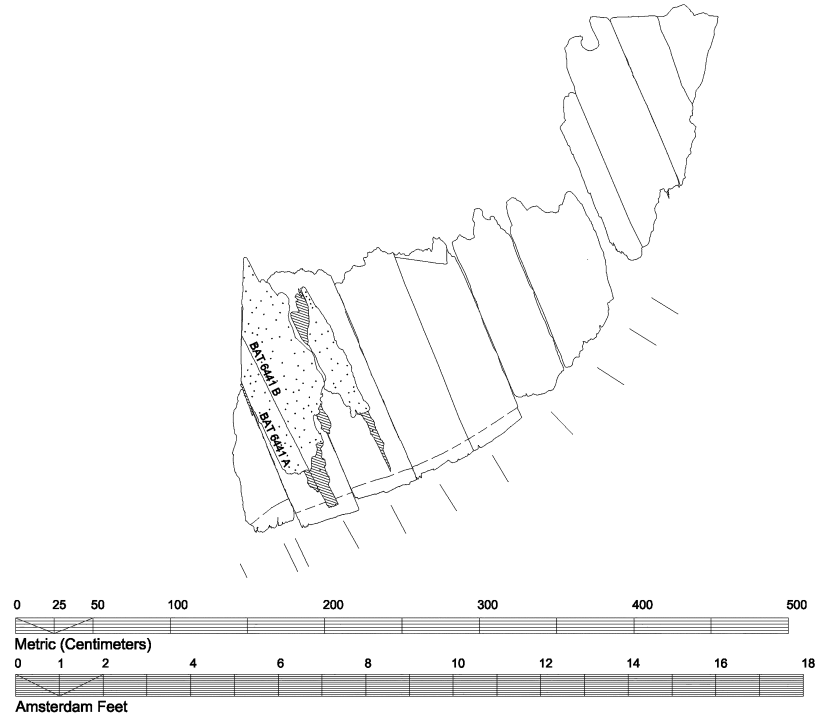
FIGURE 4-43.
Layer of pine
sheathing on
transom planking,
port side, interior
face. Inner layer of
transom planking
is outlined in gray
in the background
for orientation.
Illustration by
author.

nails were 6 to 7 cm in length, their nail shanks were 5 mm in cross section, and their heads measured 1.5 cm in diameter. The heads of all filling nails were slightly rounded at their tops. Although most of the pine sheathing planks from the transom were not recorded or mapped in situ, they ran diagonally like the transom planking (fig. 4-43). Their dimensions are similar to those of the pine sheathing of the ship's side.

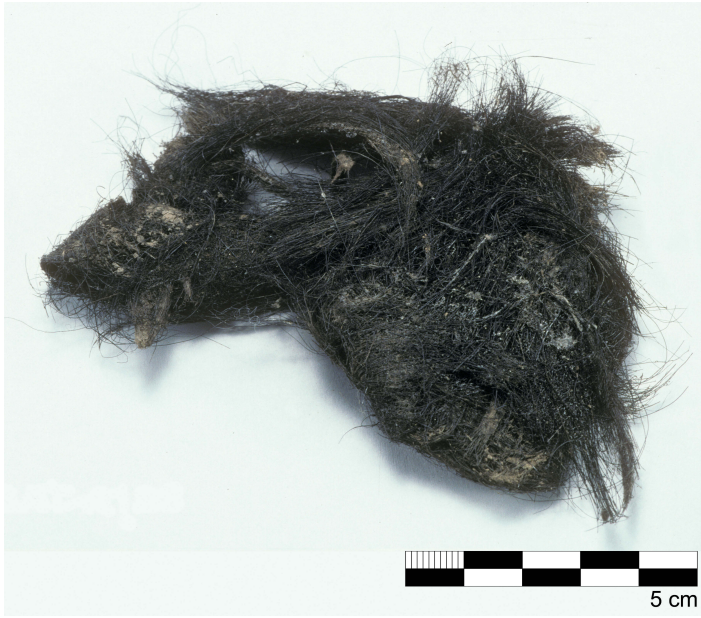
FIGURE 4-44.

Sample of goat hair from the hair layer between the inner and outer layers of hull planking, BAT 4123. Photograph by Patrick Baker, Western Australian Museum (BT-46-23).

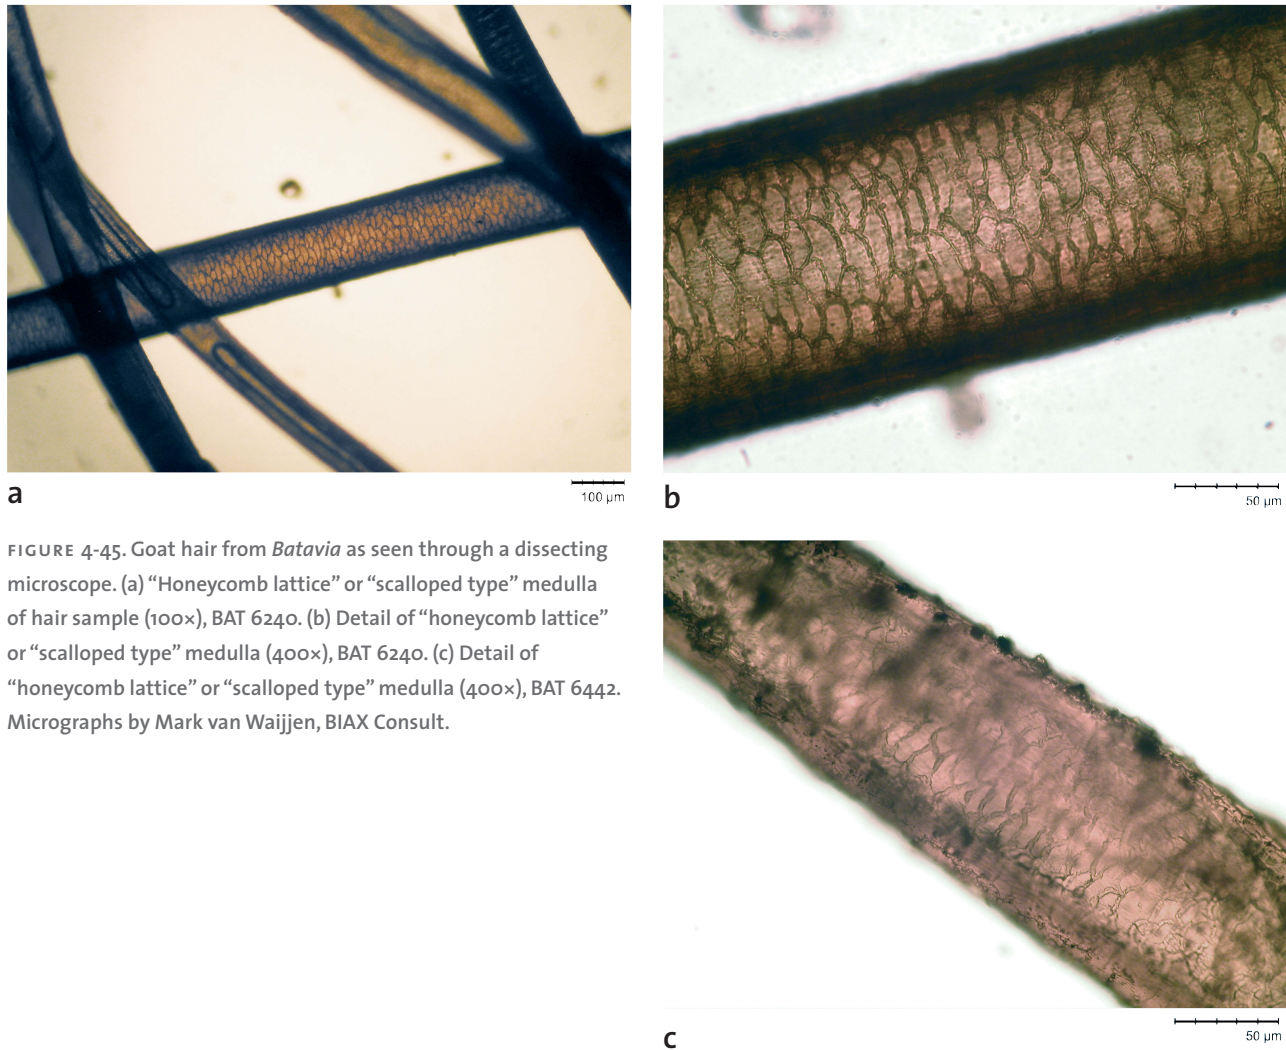
FIGURE 4-45. Goat hair from *Batavia* as seen through a dissecting microscope. (a) “Honeycomb lattice” or “scalloped type” medulla of hair sample (100×), BAT 6240. (b) Detail of “honeycomb lattice” or “scalloped type” medulla (400×), BAT 6240. (c) Detail of “honeycomb lattice” or “scalloped type” medulla (400×), BAT 6442. Micrographs by Mark van Waijjen, BIAAX Consult.

Environmental Reconstruction in the Netherlands (BIAx Consult). These specialists are trained in the identification of archaeological animal hairs from northwestern Europe and are also equipped to obtain micrographs of the hairs that can be verified by other biological archaeologists or specialists. All hairs from these two samples were identified as goat hair. The diagnostic features of goat hair are clearly visible, and some of the seven samples are remarkably well preserved considering that they were on the seabed for more than 300 years. The cross-sectional outline of the hair is dumbbell shaped, characteristic of the hair of goats, rabbits, and hares. Goat hair, however, also has a distinct medulla pattern referred to as “scaloped” or a “honeycomb lattice,” which is clearly visible in figure 4-45. This medulla nearly fills the entire hair, which results in a thin cortex.⁴⁵

The *Batavia* hair samples are composed mainly of tufts of fur and diagnostic guard hairs, indicating that these hairs derive from the same type of animal (see fig. 4-45).⁴⁷ This also indicates that the goat hair was used in its entirety, including the underwool. In general, the preserved goat hair found on the *Batavia* ship’s timbers seems to have come from black or dark brown goats.

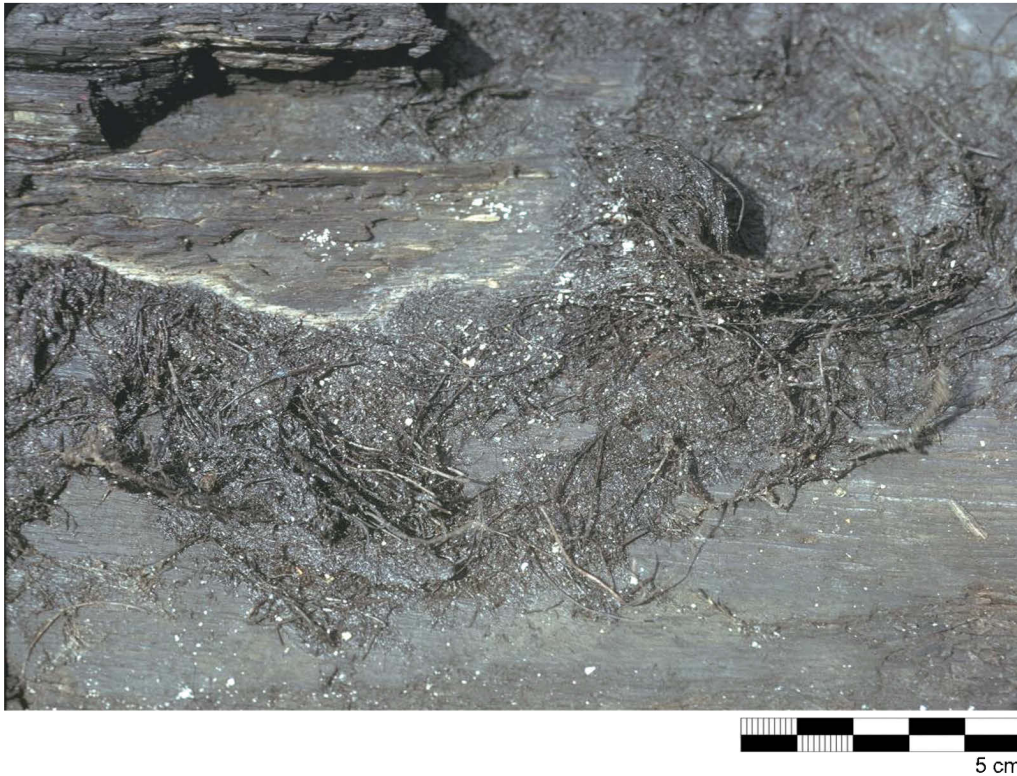
FIGURE 4-46.
Moss layer on exterior
surface of inner layer
of a vertical scarf, BAT
6404. Photograph by
Patrick Baker, Western
Australian Museum
(BT-67-09).

In addition to goat hair, a mosslike material was found between the ends of a vertical flat scarf of hull plank BAT 6404, the aftermost end of strake 13 (approximately 80 cm forward of the transom). Most of the original overlying exterior end of this scarf had disintegrated on the seabed, exposing on the exterior face of the inner scarf what could have been moss as luting or coating in between the two scarf ends. The material was not sampled before conservation for species identification. Unfortunately, it was not preserved during the timber’s conservation treatment so is no longer available for further investigation and analyses (see figs. 4-17 and 4-46).

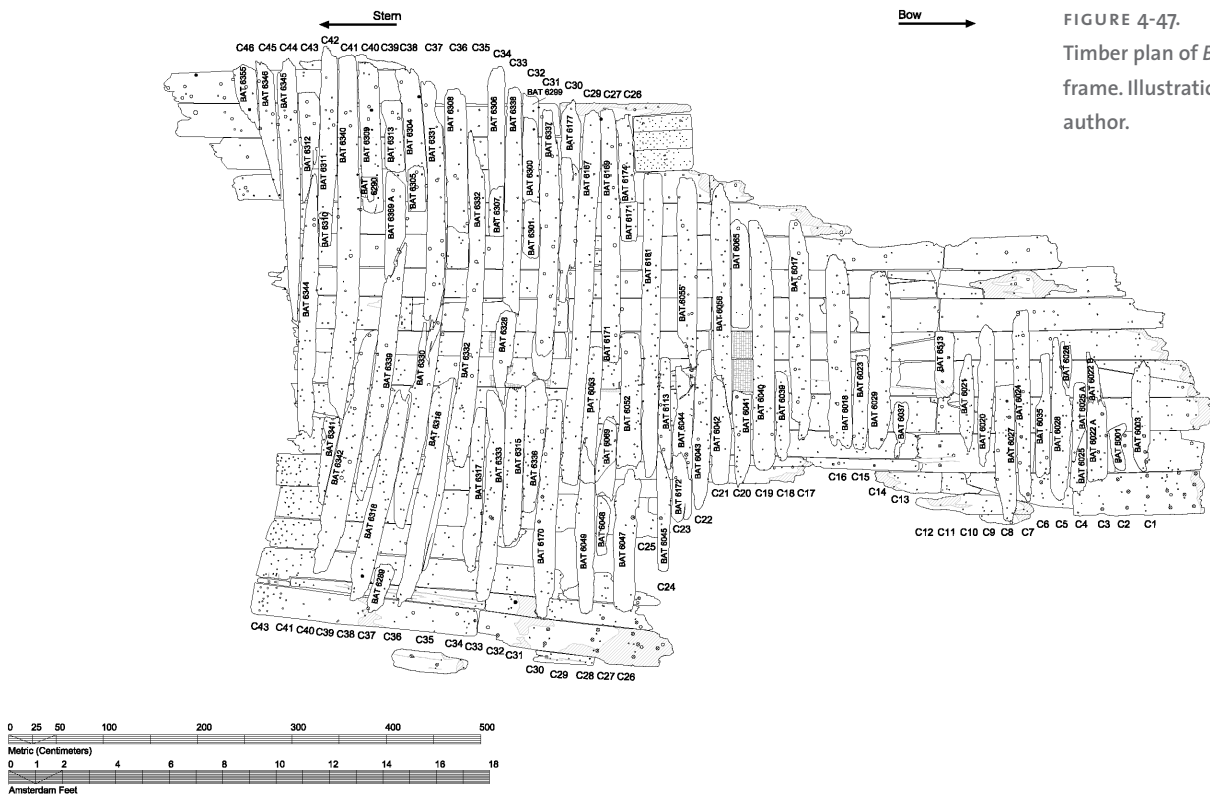
FIGURE 4-47.
Timber plan of *Batavia*'s
frame. Illustration by
author.

Forty-six remnants of *Batavia*'s framing have been preserved (C1–C46), mainly comprising first, second, and third futtocks (figs. 4-47 through 4-49). The only possible remnant of a floor timber is a small timber fragment, BAT 6289, found at C37 over hull planking strake 4. Looking at *Batavia*'s frames makes evident that the efforts of the ship-builders were not focused on its frames, as their arrangement and shape have a haphazard and rough appearance in comparison to that of the hull planking (see fig. 3-29). They obviously were a secondary focus, not primary in the design philosophy of the shipwrights.

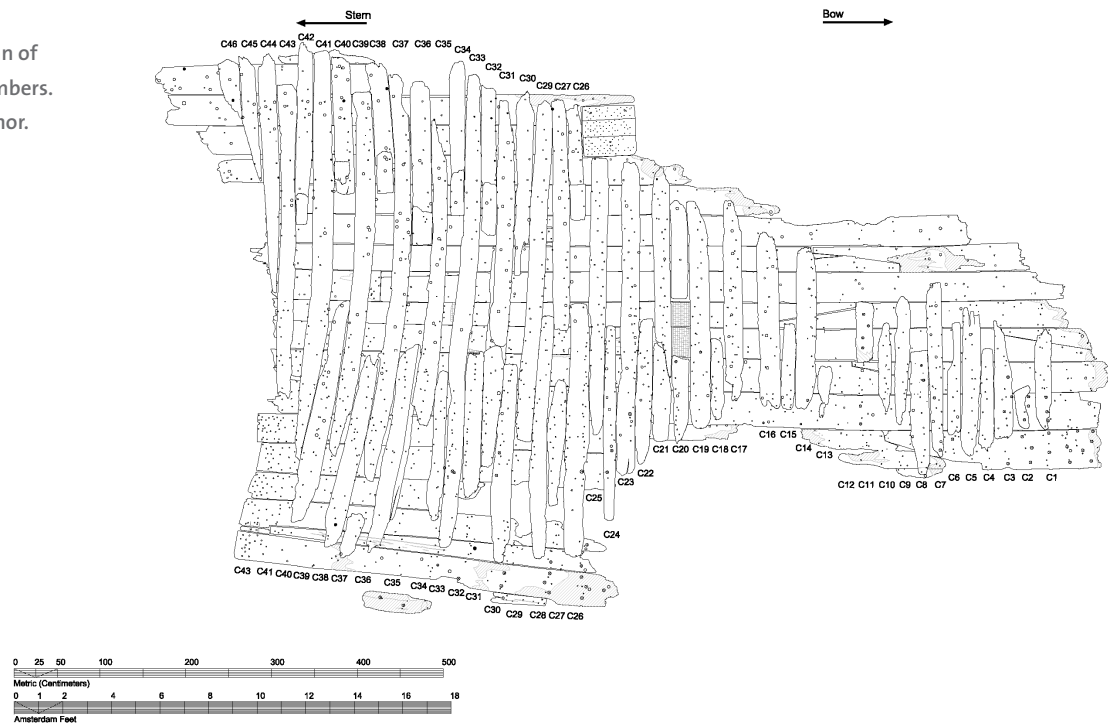
FIGURE 4-48.
Reconstruction plan of
Batavia's frame timbers.
Illustration by author.

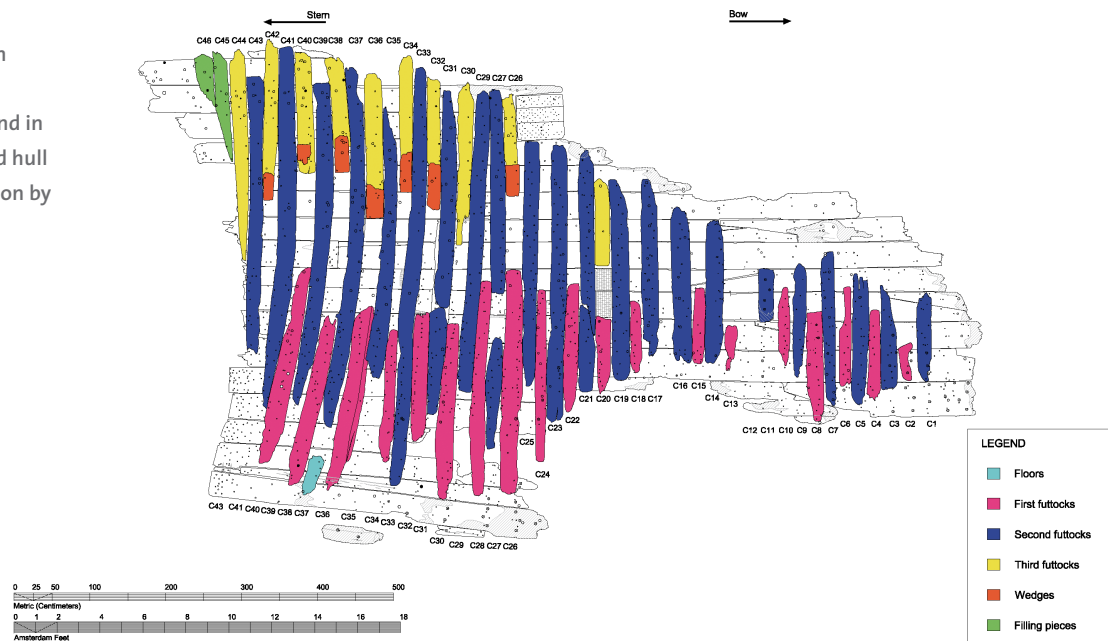
FIGURE 4-49.
Reconstructed plan
showing types of
frame timbers found in
Batavia's preserved hull
structure. Illustration by
author.

been preserved over the entire preserved hull section. The first and second futtocks and second and third futtocks are not interconnected or transversally fastened but overlap each other at their ends to form an irregular band of timber. The frame timbers are preserved over lengths varying from 51.3 cm to 3.97 m, with an average length of 1.76 m. Their average sided dimension is 20.7 cm and average molded dimension is 19.1 cm. The room and space between the second futtocks varies from 35.3 to 48.2 cm, with an average of 41.4 cm (see fig. 4-49).

Wedges were nailed over the lower ends of the third futtocks to fill the space between the beveled frame ends and the ceiling planks above the shelf clamp (see fig. 4-49). Seven of these preserved wedges are triangular in cross section and vary from 18.4 to 61.6 cm in length and from 14.5 to 26.4 cm in width (fig. 4-50). Their maximum thickness is between 9 and 17.5 cm on their lower ends, from which they taper to a point at their top ends where they sit over their respective frames.

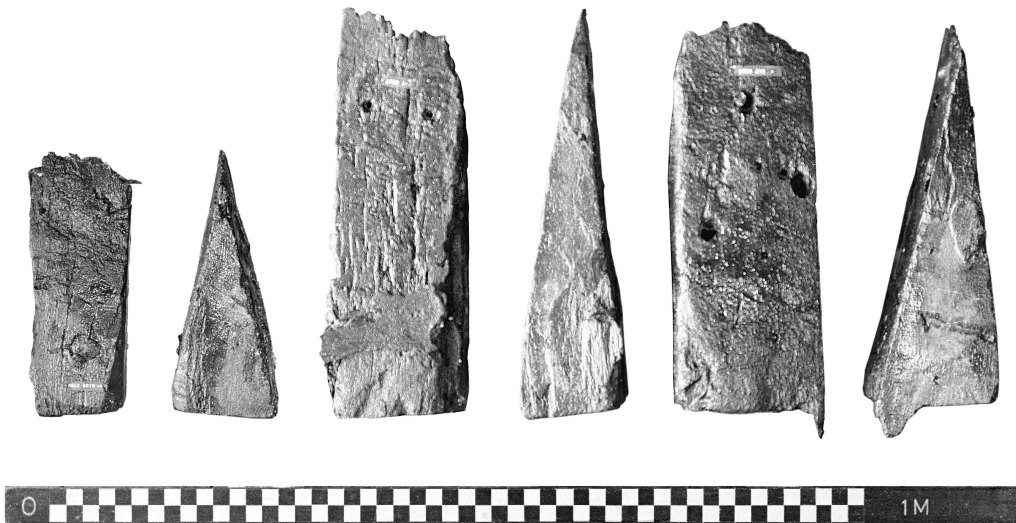
FIGURE 4-50.
Various sizes of wedges
from the lower ends
of the third futtocks,
BAT 6310, BAT 6307, and
BAT 6305. Photograph
by Patrick Baker,
Western Australian
Museum (MA0422-04,
MA0422-05,
MA0423-09, and
MA0423-10).
